Diagnostic analysis of Baroda branch canal of Som Kamla Amba irrigation project, Rajasthan, India

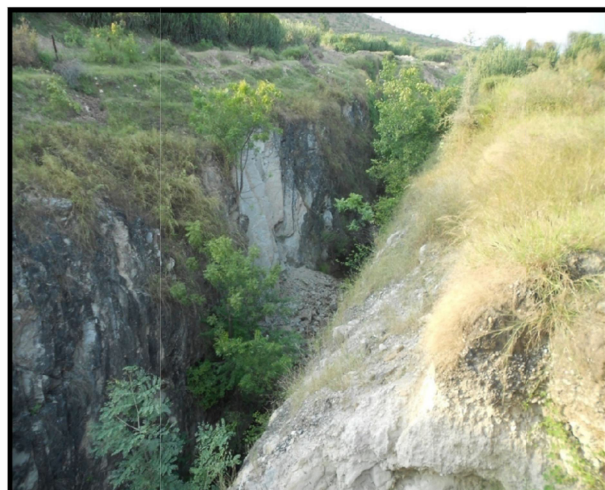
Seepage and overtopping were the two major problems in the command area because of blockage of canal water due to sliding of sides of valley (figure 2) and damaged lining (figure 3) therefore maintenance is requiring, but no action is taken on behalf of Irrigation Department due to unavailability of maintenance funds. The second problem is siltation. The depth of silt is ranging between 35-40 cm. The vegetative growth was found at both bank of canal which is also one major problem which covers the canal at many locations.

Figure 3: Blockage of canal water due to sliding of sides of valley in BBC at RD:187 chain

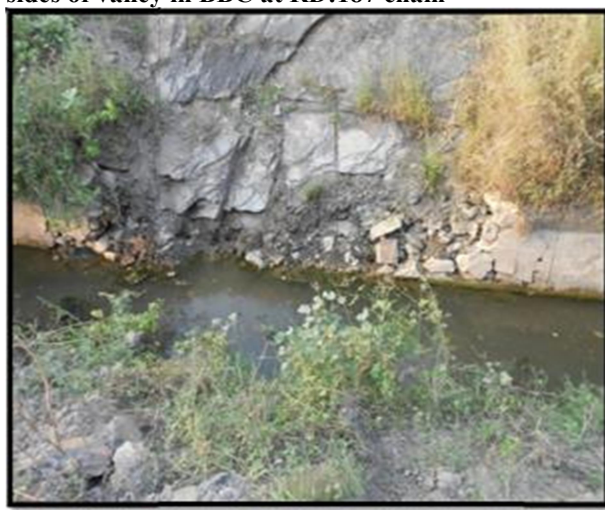
The trees like babul, neem, khajur, etc. also grown both the sides, which results in damaged lining and also covers canal at both sides (figure 4 & 5). To maintain and preserve ditch and canal banks, vegetative growth, particularly grasses such as Bermuda, Bahia, or St. Augustinegrass, can be employed. The plant species should have broad root systems capable of retaining soil and be robust enough to supply sufficient hydration to the plants throughout the dry spring season, i.e., vegetation should maintain good cover and growth throughout the year to successfully safeguard the banks from eroding (Diaz *et al.*, 2014). However, mismanagement of vegetation can result in restricted access and inspecting capabilities, root damage, operational disruptions, obstructions, and habitat for burrowing animals, all of which increase the probability of canals deteriorating. Each year, a number of canals collapse, which are frequently due to poor vegetation upkeep. These failures can result in major economic losses, loss of project benefits, personal injury, and even death (Reclamation, 2017). The control gates were found

Figure 4: Damaged lining of BBC at RD:223 chain

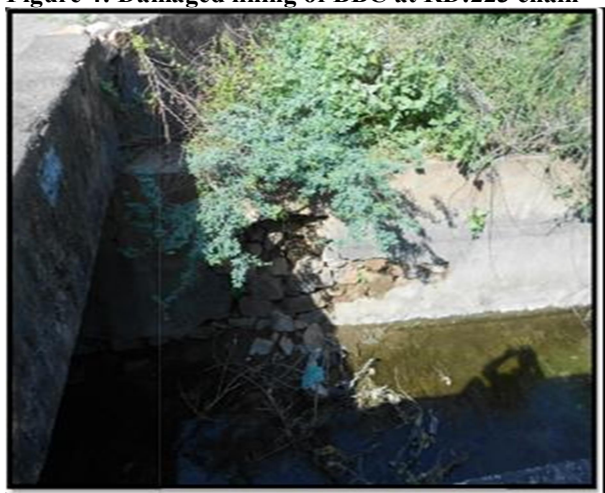
Figure 5: Damaged lining of BBC due to Babul at RD:310 chain

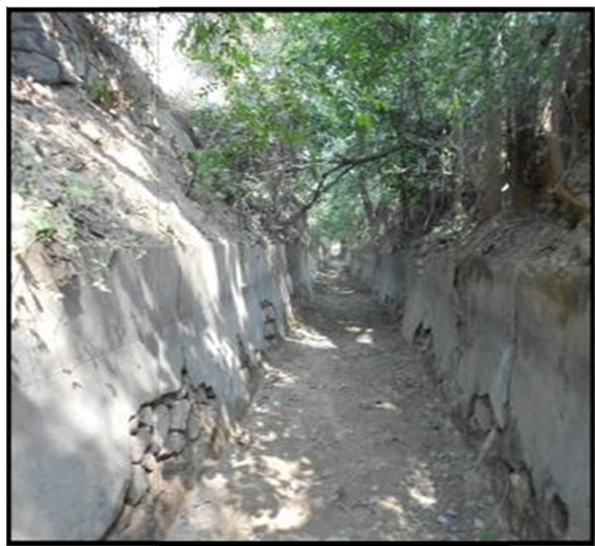
Figure 6: Damaged lining and trees are grown on sides of BBC at RD:517 chain

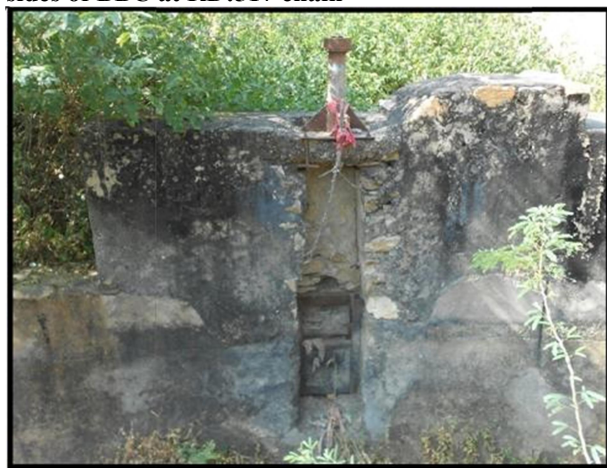
This minor is situated on the middle of BBC and off takes at RD 432 chainage. This minor has a length of 81 chains. The culturable command area of this minor is 129.0 ha. The sluice gate was found damaged (figure 6) of Chundiyawara minor-I. The vegetative growth was found at both banks of the minor, which covers the minor at many locations. The problem of seepage was also found, and also this minor is affected by the problem of siltation. The depth of silt ranges between 20-25 cm. The culturable command area of this minor mainly exists in Chundiyawara village.

Figure 7: Damaged sluice gate at the head of Chudiyawara minor-I in BBC at RD:432 chain
