Revitalization of Rawa Pening lake, Indonesia

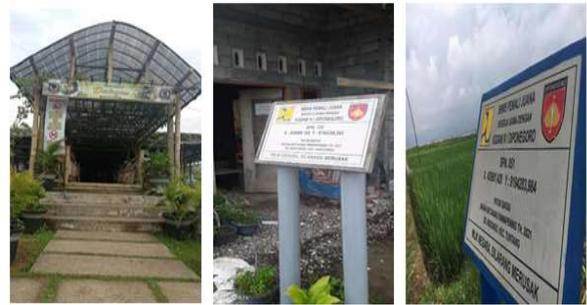
Figure 2: Blue pegs on the boundary of the lake area.

Daringan Culinary Park, Blue peg on the community house, Blue peg on resident's rice field

Second. Village Treasury Land, is land controlled or owned by the village government as one of the original sources of village income for social benefit. Provision of Village Treasury Land: a) it is used for the sake of village development and community service; b) position land which is the provision to village officials as additional income for their service while serving as village officials; c) as a tribute to officials who have completed their duties; b) lands that have general functions and social functions such as fields, cemeteries, village halls, and so on. Kesongo Village located in Tuntang District is one that has village treasury land that is used for public interest to increase the village's original income and carry out social functions. Village treasury land is used for rice fields that are managed by the community, parking lots by fishermen and fish cage owners, and culinary tourism (Figure 2).

Yellow and blue pegs mark the corresponding lake and riparian areas which aim to protect the lake area and restore the lake's function as it supposed to be. However, in its implementation, it causes anxiety in the community because the pegs that have been installed are in buildings and land owned by the community that has been certified and is still in the form of letter C, which has the potential to cause conflicts between citizens and state officials. On the other hand, it has an economic impact in the form of decreasing income and shifting livelihoods because people lose land rights. The following is an inventory of certified land parcels downloaded from the Semarang Regency Land Office in 2022 (Table 3). Land ownership status within the lake or riparian areas is as follows: 1) If the lake boundary land is used for city facilities, buildings, roads, or public facilities, it will remain unaltered, maintained as long as no reason is found that is more important than its current benefits; 2) If the lake boundary land is owned by the community, its original purpose must be returned as a riparian, as long as the ownership rights to the land are validly recognized, but the landowner must comply with the designation of the land as a riparian area; 3) Buildings that have already been established on the riparian area are declared in the status quo, i.e., cannot be changed, added, and repaired and new construction permits will no longer be issued; 4) Community land acquisition with a comprehensive land procurement mechanism both in lake bodies and riparian areas

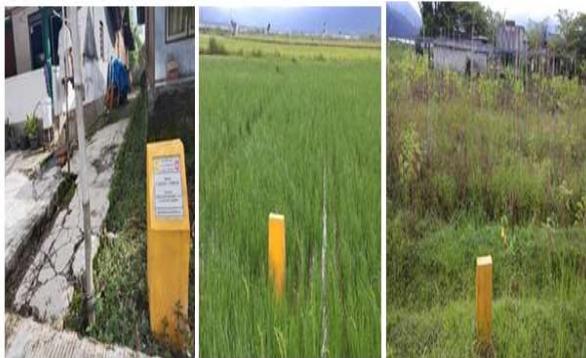
Figure 1: Yellow pegs on the riparian area

Yellow peg in front of the community houses, Yellow peg on community rice fields, Yellow peg on the community land

on the lake boundary. The forms of land ownership around Rawa Pening Lake are as follows: first, the Letter C document, is a land register book that exists in the village for generations and is stored in the respective village office. Meanwhile, residents who own the lands are only given the excerpts of Letter C. Before the land registration activity, Letter C was a basis for the withdrawal of land tax and strong evidence that explained that the land was a customary property right and the name listed in Letter C was the taxpayer so that the registration was through conversion. Letter C is the basis for the issuance of land title certificates (Figure 1).
